## Infrared Thermographic Survey of Nominated Electrical Equipment

### Sample Report P/L

Job Number Reference: - TI001101

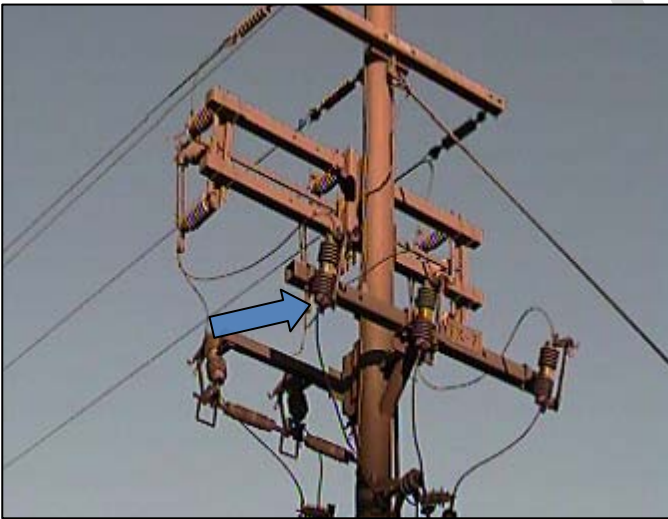
**Plant:-** Sample **Equipment:-** LHS Dropout fuse

**Location:-** HV Power line outside workshop **Priority Rating:-** MEDIUM - HIGH

Image info	Value
Amb Temp	17.5 °C
Emissivity	1
File Name	IR_76 - sat00953.sat
Eff Dist	7m
Shooting time	---
Rel Hum	Low
Max Temp	65.85 °C
Min Temp	-23.24 °C
Chart	Value
C1:Max Temp	65.85 °C
C2:Max Temp	20.88 °C
C3:Max Temp	17.73 °C

**Additional Comments:-** Localized hot spot shown at base of LHS fuse feeding Transformer.

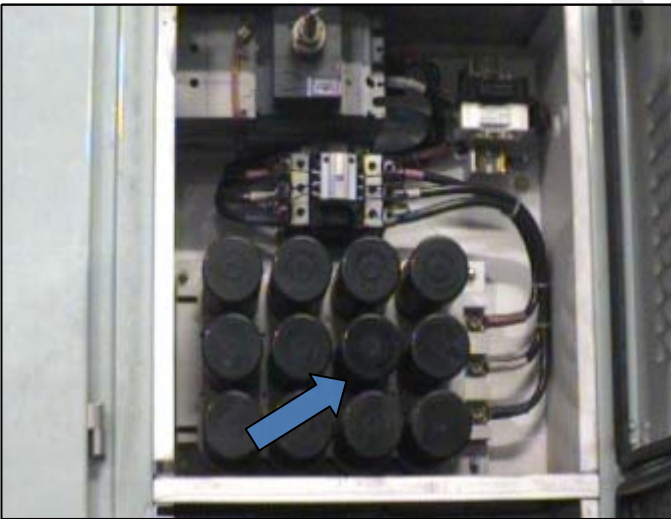
**Plant:-** Sample **Equipment:-** PFC, 04F-0

**Location:-** Factory Power Factor Correction Board **Priority Rating:-** **HIGH**

Image info	Value
Amb Temp	22.9 °C
Emissivity	1
File Name	IR_40 - sat00905.sat
Eff Dist	1m
Shooting time	---
Rel Hum	Low
Max Temp	66.29 °C
Min Temp	25.84 °C
Chart	Value
C1:Max Temp	49.91 °C
C2:Max Temp	65.85 °C

**Possible Cause:-** Worn equipment.

**Additional Comments:-** Capacitor shown to produce excessive heat compared to others.

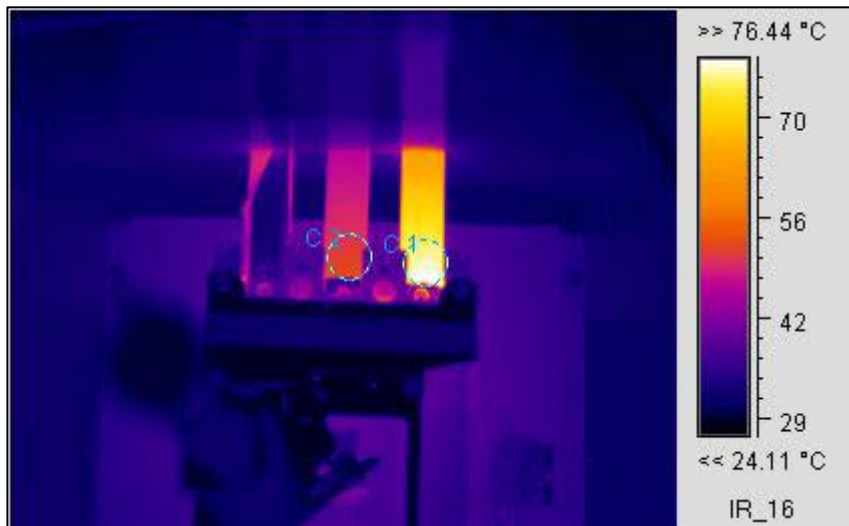
**Plant:-** Sample **Equipment:-** Main Circuit Breaker

**Location:-** Primary Crusher 1 **Priority Rating:-** MEDIUM - HIGH

Image info	Value
Amb Temp	22.3 °C
Emissivity	1
File Name	IR_16 - sat00886.sat
Eff Dist	1m
Shooting time	---
Rel Hum	Low
Max Temp	77.11 °C
Min Temp	23.42 °C
Chart	Value
C1:Max Temp	77.11 °C
C2:Max Temp	52.38 °C

Current in Amps Per Phase		
Red	White	Blue
104	105	105

**Possible Cause:-** Termination on blue phase requires further investigation.

**Additional Comments:-** Localized heat source shown on blue phase.
